CALSPAN ON-SITE AIR BAG DEPLOYMENT INVESTIGATION

CALSPAN CASE NO. 92-4

VEHICLE - 1986 FORD TEMPO GL

ACCIDENT DATE - ██████████ 1991

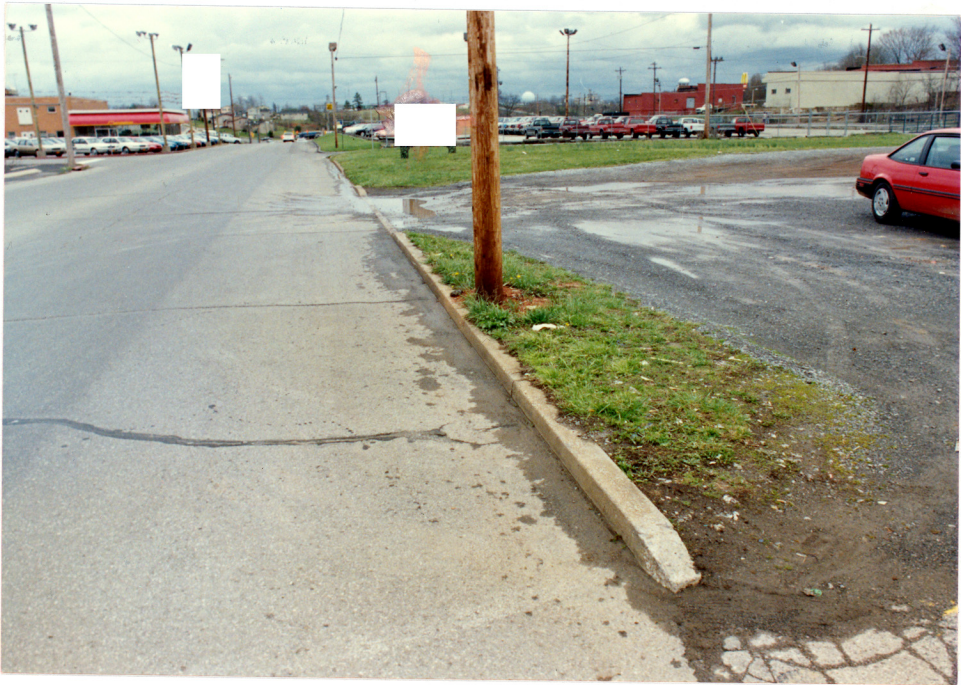
The right frontal area of the vehicle impacted a small diameter utility pole that was located 1' outboard of the curbline. Impact speed was computed at 14.0 mph by the damage and trajectory algorithm of the CRASHPC program. Direct contact damage began 5.6" right of center and extended 8" to the right on the front bumper face. Maximum crush was 14.75" and was located 13.1" right of center. The vehicle underwent a velocity change of 16.7 mph which was sufficient to deploy the vehicle's driver air bag system.

Struck Utility Pole.

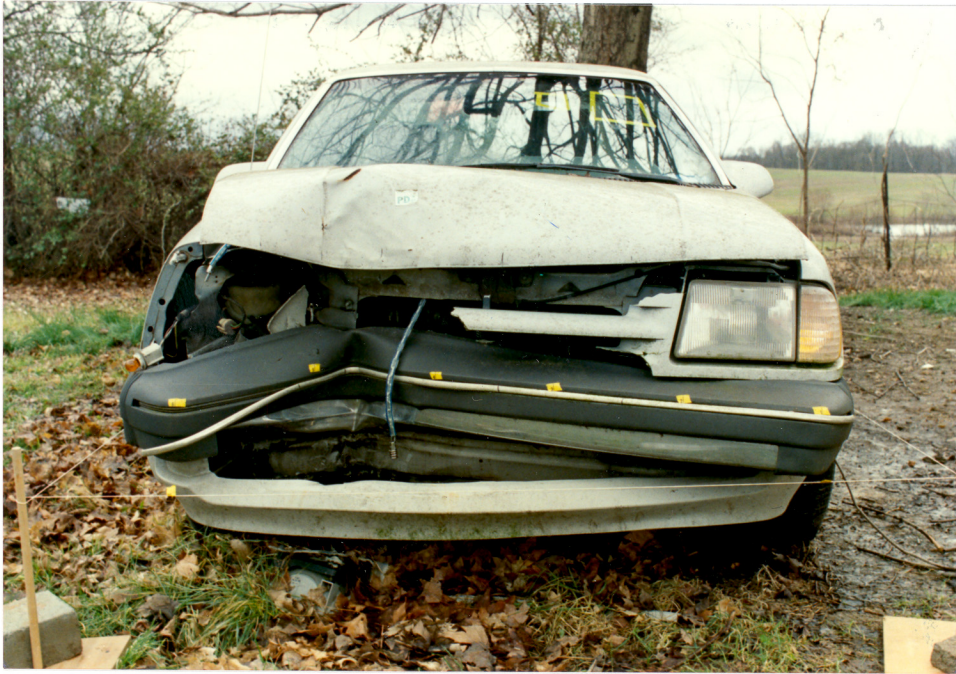
The Ford Tempo sustained moderate frontal damage as a result of its impact sequence with the wooden utility pole. Maximum crush was 14.75" located on the bumper face 13.1" right of center. Direct contact damage began 5.6" right of center and extended 8.0" to the right. The impact deformed the entire frontal width of the vehicle which resulted in a combined induced and direct contact damage length of 48". Crush values at bumper level were as follows:  $C_1=0"$ ,  $C_2=2.0"$ ,  $C_3=6.0"$ ,  $C_4=10.375"$ ,  $C_5=12.0"$ ,  $C_6=5.75"$ .

Components damaged by the narrow frontal impact sequence included the front bumper, grille, right headlamp assembly, hood, radiator and radiator support panel, and the air conditioning condensor. The impact crushed the bumper to a V-configuration which displaced the front frame rails laterally inward. As a result of the rail displacement, the right front air bag crash sensor was rotated both inward and upward. The left crush sensor was rotated slightly clockwise.

Frontal Damage To The Ford Tempo.

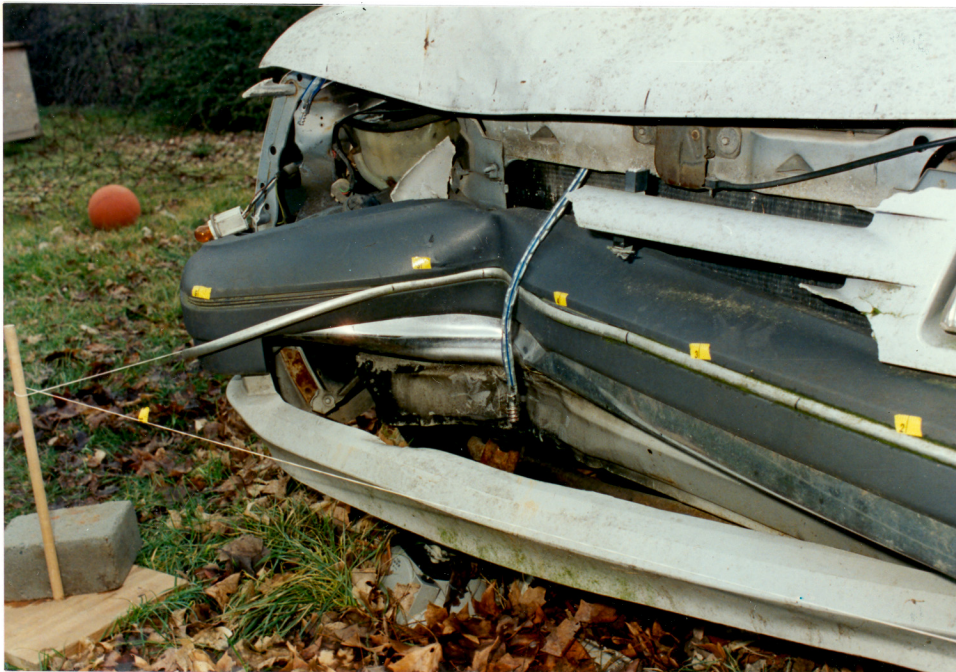
Closeup View Of The Pole Impact Damage.

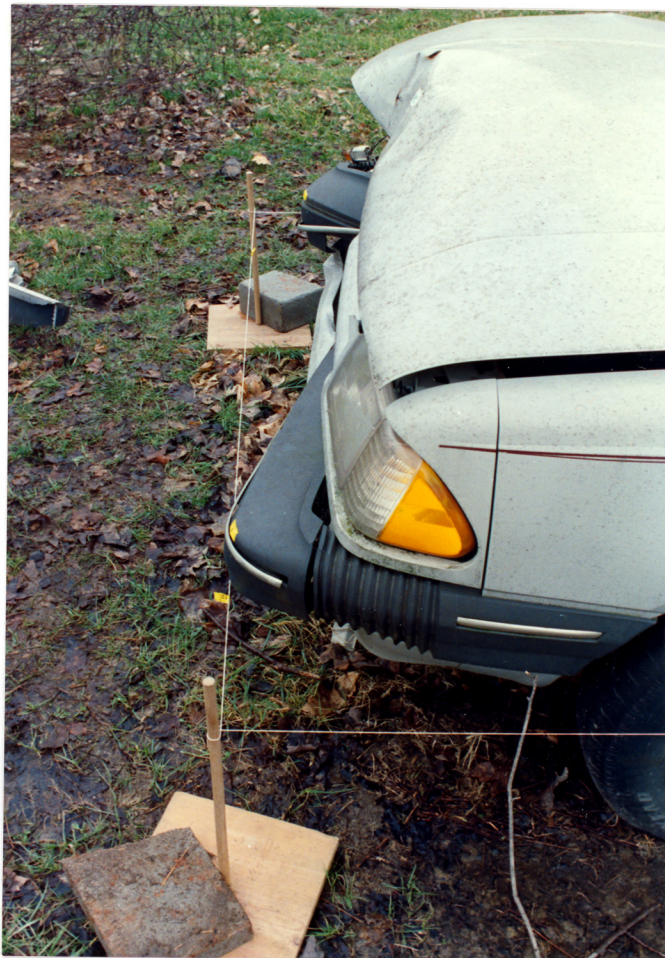
Left Perpendicular View Showing The Extent Of Crush.

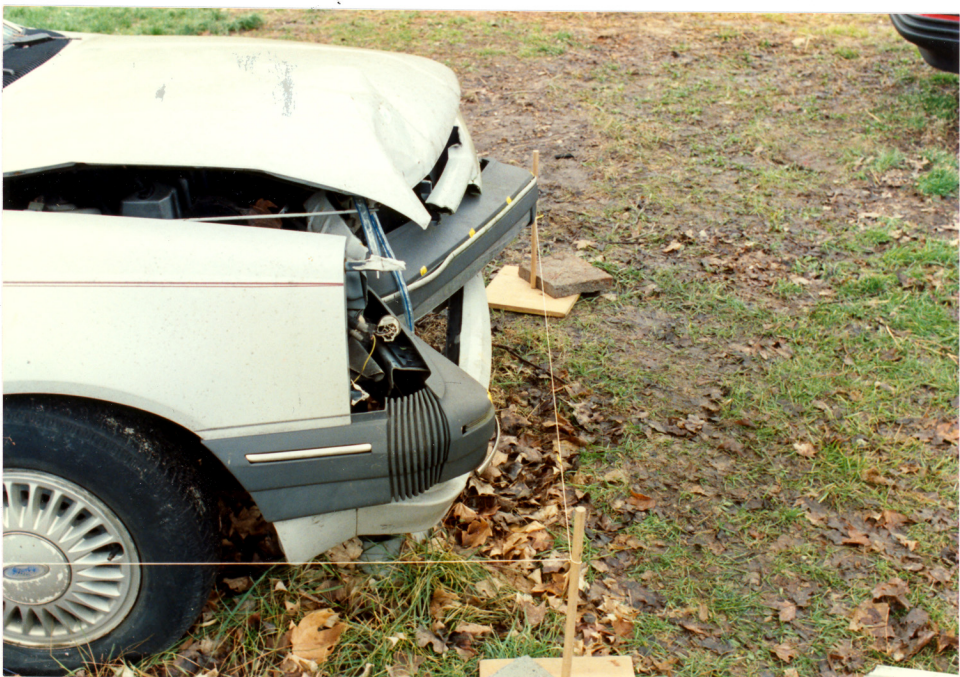
Right Perpendicular View Showing The Extent of Crush.

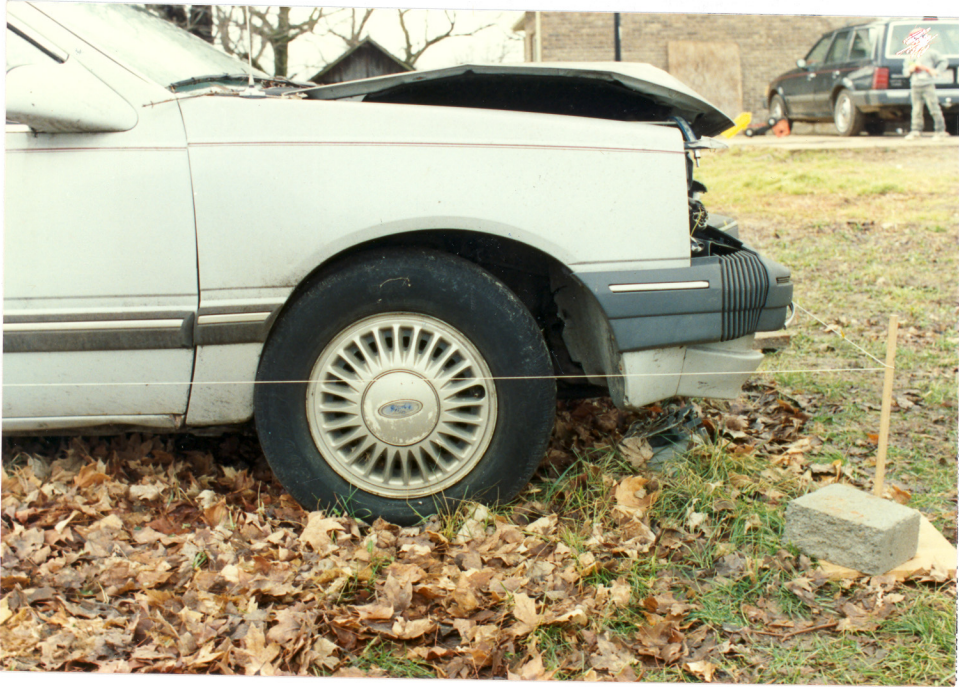
The windshield was cracked as a result of impact induced stress and occupant contact. All doors remained closed and operational post-crash. The right wheelbase was reduced in size by 3.1"; however, the right front wheel was not locked by damage.

Rearward Displacement (3.1") Of The Right Front Axle Position.

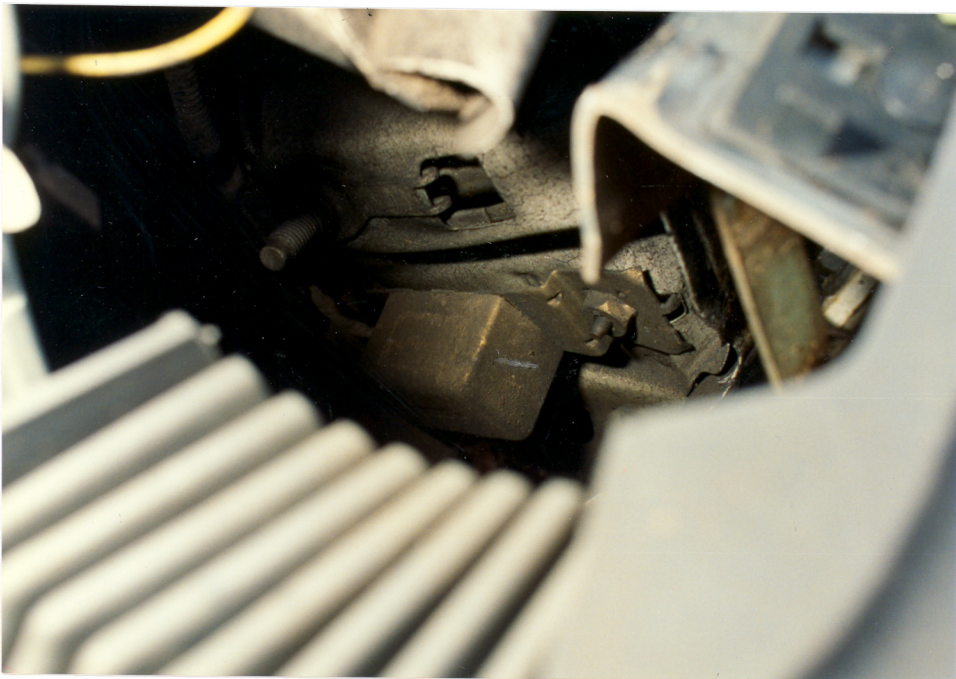
Front Right Air Bag Crash Sensor.

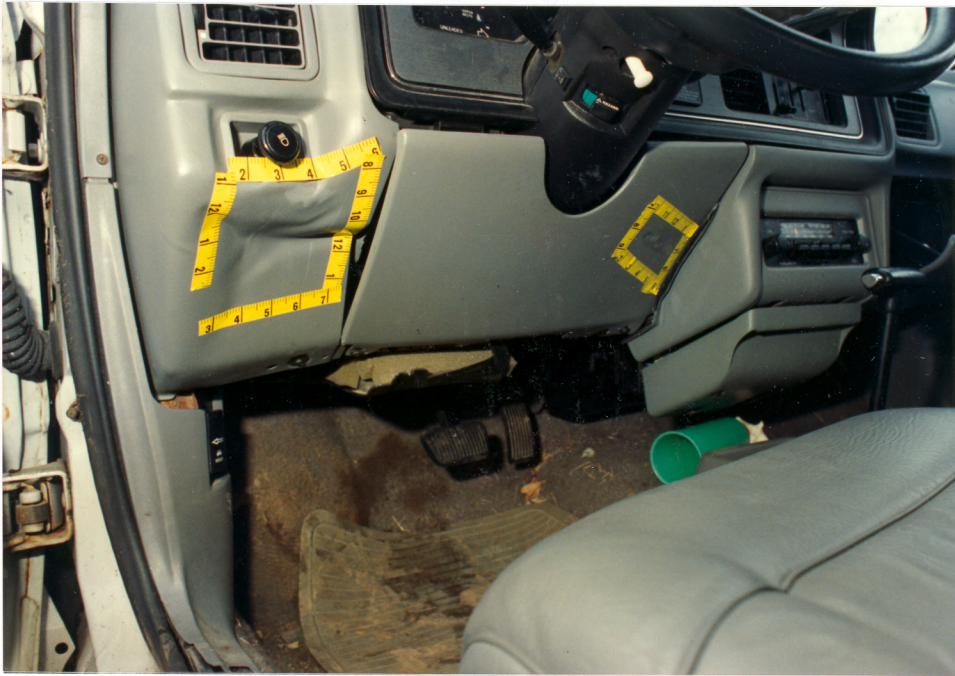
The interior of the Ford Tempo sustained moderate damage as a result of the crash forces and driver contact with interior components. The driver's left knee impacted the lower instrument panel immediately below the light switch. The contact produced a fabric patterned abrasion to the padded component 21.5-24.5" left of center and 11.5-15" below the upper instrument panel and deformed the panel to a depth of 1.25". Her right knee impacted the right side of the knee bolster and deposited a blue/black fabric transfer with an abrasion to the plastic panel. The contact, which was located 6.5-10.5" left of center and 13.75-14.875" below the upper panel, displaced the right side of the bolster 0.5" forward. The driver's abdominal area loaded the upper edge of the steering wheel rim as the wheel was rotated approximately  $180^\circ$ . Her loading force displaced the rim 3.25" forward and compressed the energy absorbing steering column 1.1" (shear capsule separation). The deformable bracket of the steering column had a residual displacement of 0.75". The driver's right hand probably separated from

Driver Knee Contacts To The Lower Instrument Panel And Knee Bolster.

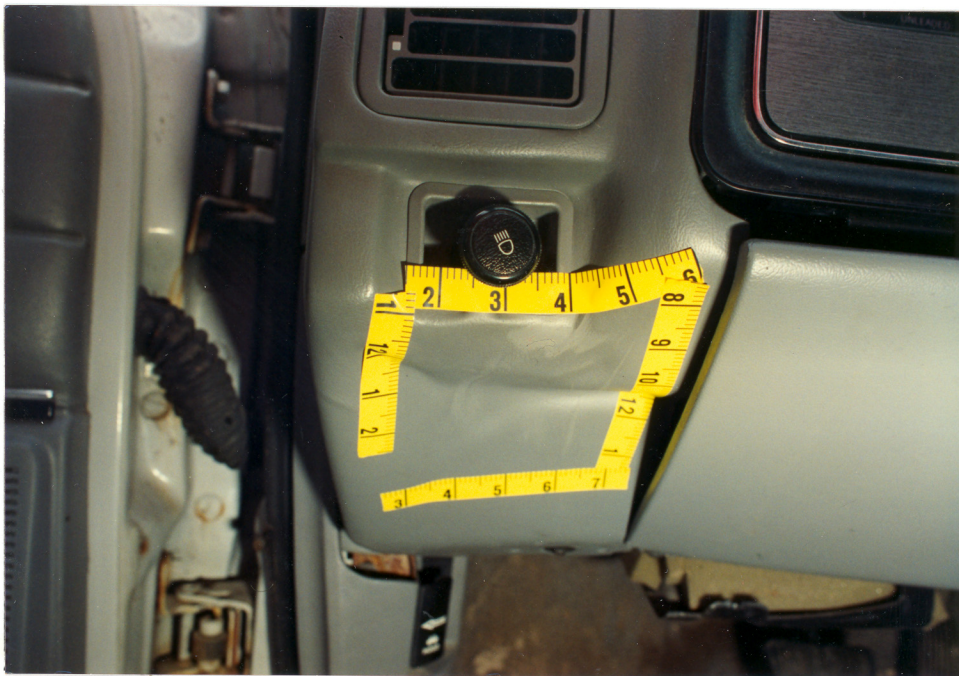
Left Knee Contact To The Lower Instrument Panel.

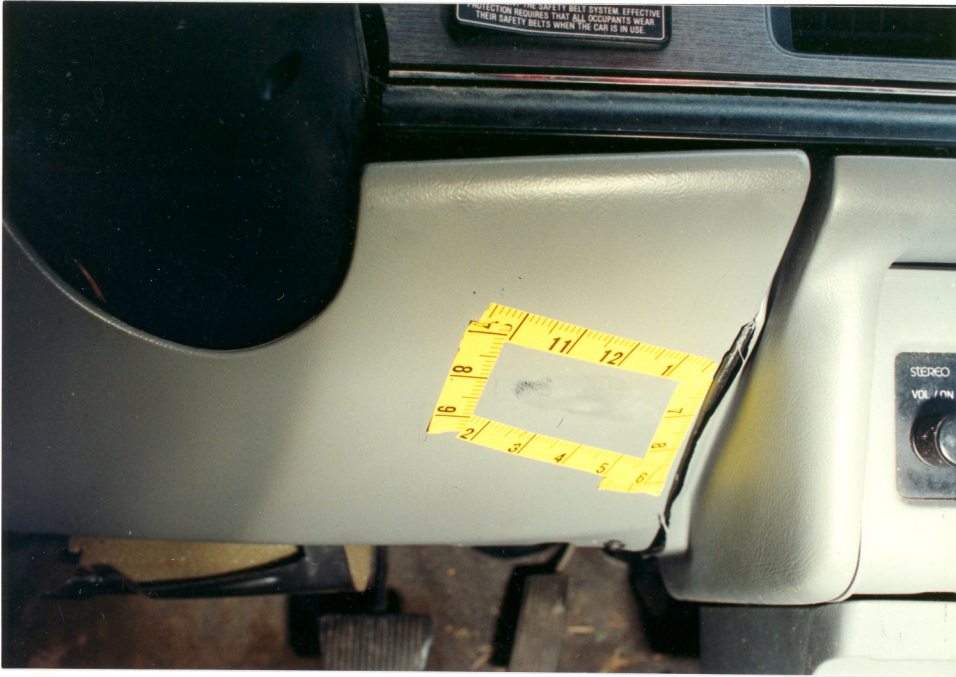
Right Knee Contact To The Knee Bolster.

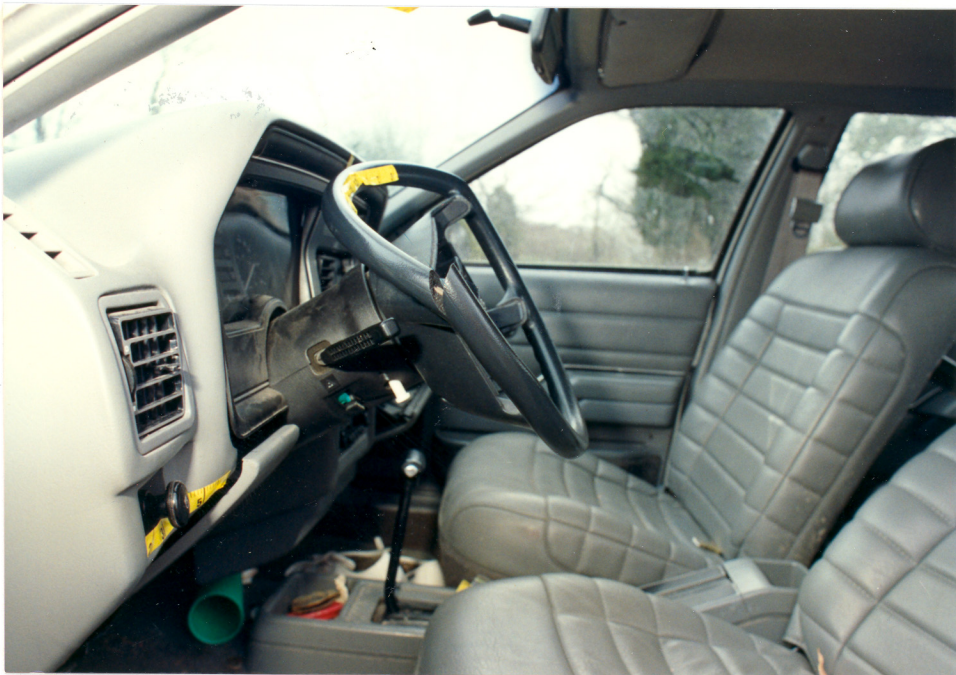
Due to the driver's forward position at impact, her upper abdominal area loaded the lower edge of the steering wheel rim (wheel was rotated 180° at impact) and deformed the rim 3.25" forward. Her contact with the soft edged steering wheel rim resulted in ecchymosis of the upper abdominal area and a ruptured spleen. Her torso contacted the deployed driver's air bag which resulted in bilateral breast contusions. As a result of her loading force against the steering wheel rim and the deployed air bag, the energy absorbing steering column compressed 1.1" (shear capsule compression).

Driver's Abdominal Loading Of The Steering Wheel Rim  
(Wheel Was Rotated 180° At Impact).

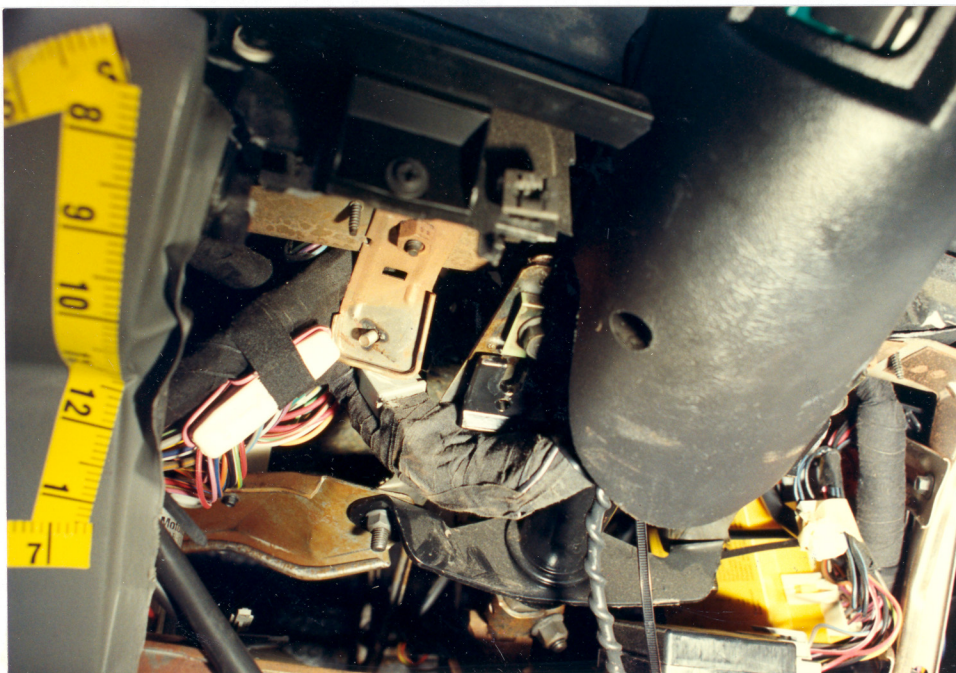
Left Shear Capsule Separation And Bending Of The Deformable Bracket.

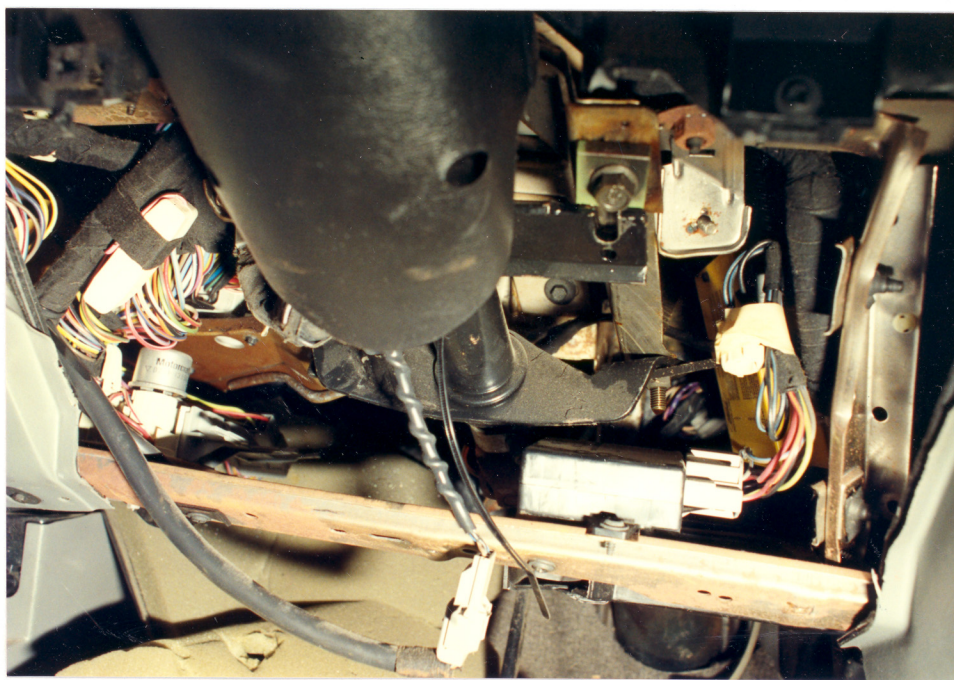
Right Shear Capsule Separation.

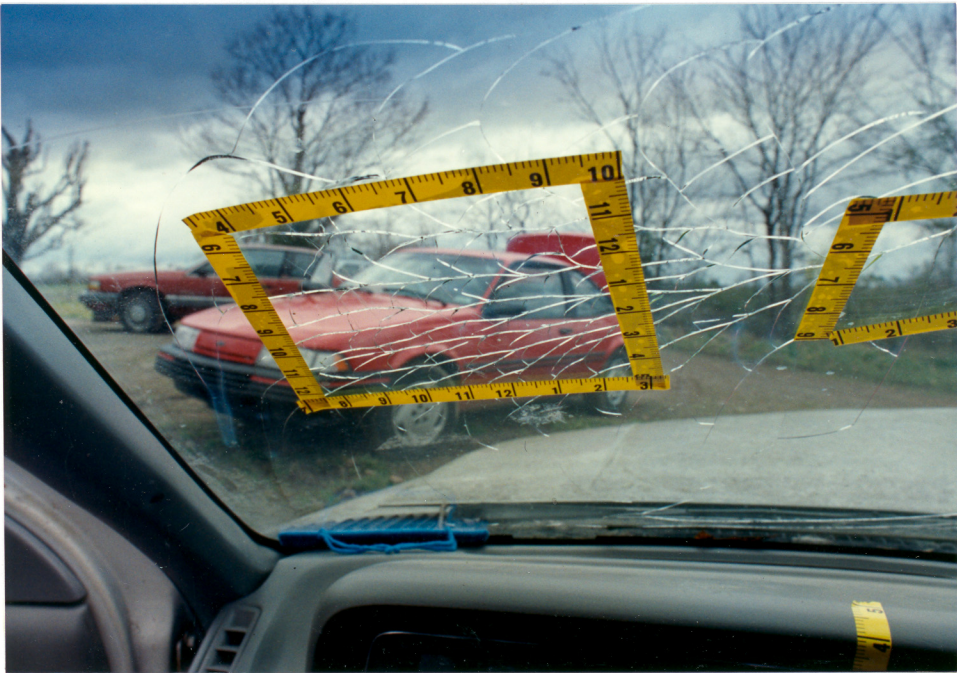
Probable Air Bag Contact To The Windshield.

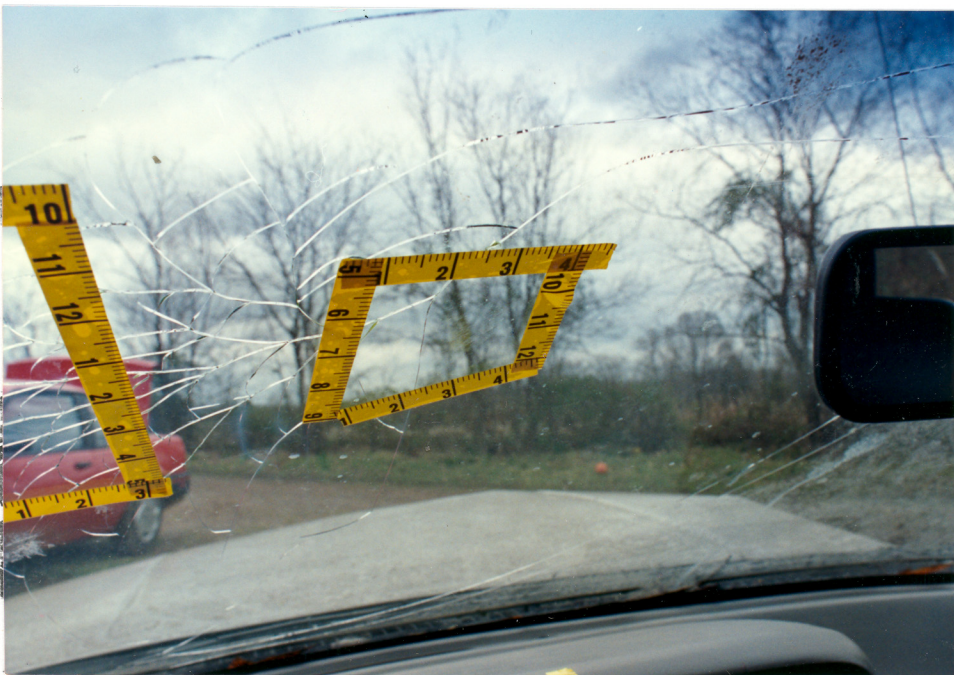
The driver's forehead area pitched over the top of the air bag and impacted the windshield 6.5-9" left of center. The contact cracked the laminated glass and deposited tissue transfers on the glass 6.5-9" above the upper panel. No injury resulted from her contact with the windshield. Vertically oriented fabric transfers were noted to the windshield 13-19" left of center which resulted from air bag contact with the glass.

Driver Forehead Contact To The Windshield (Tissue Transfer).

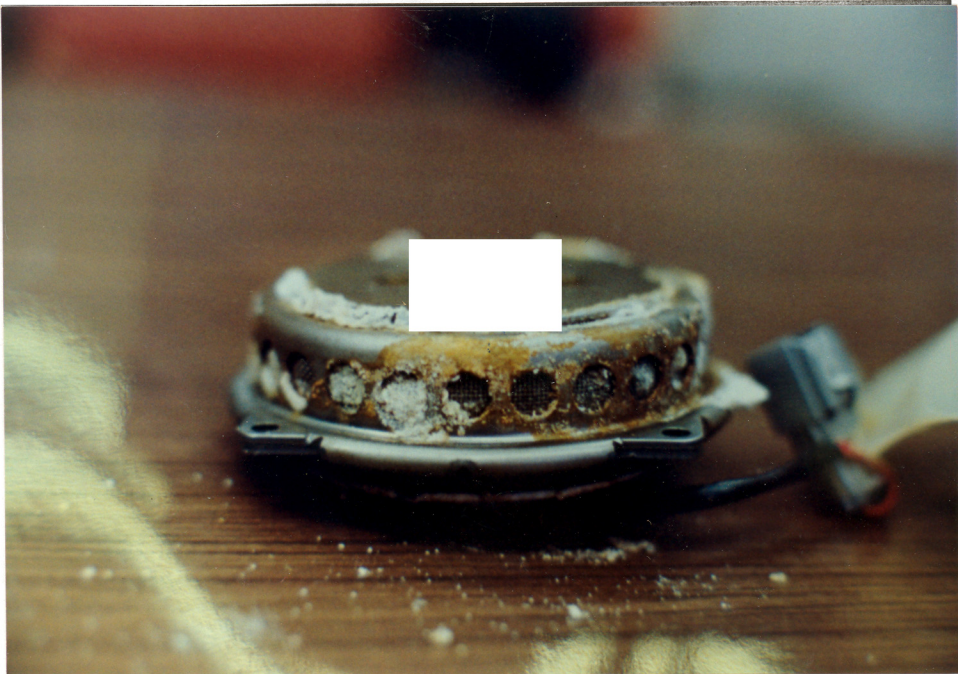
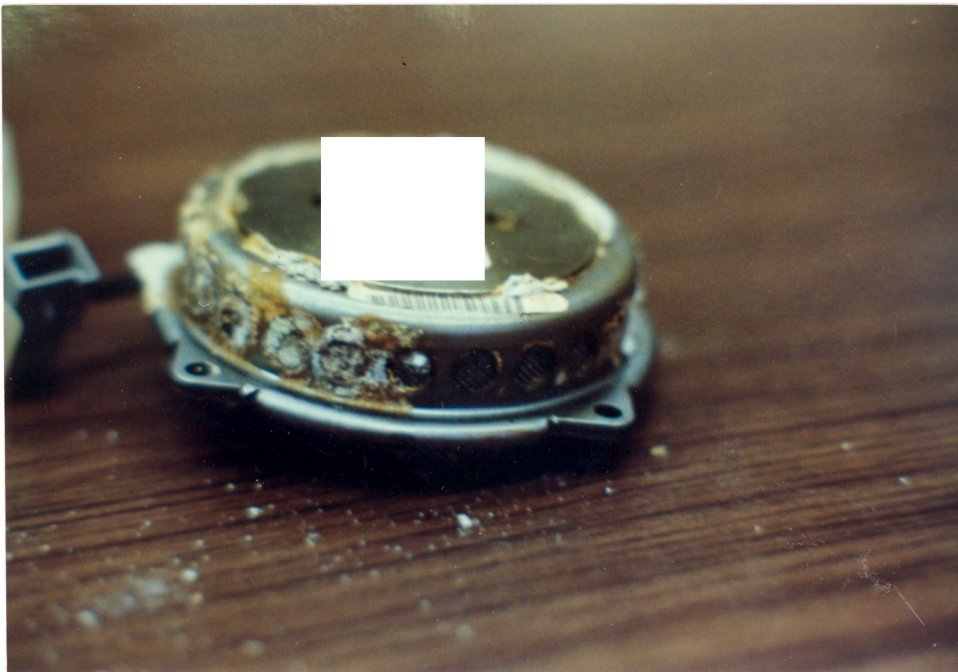
Generant Residue Deposits On The Inflator Ports.

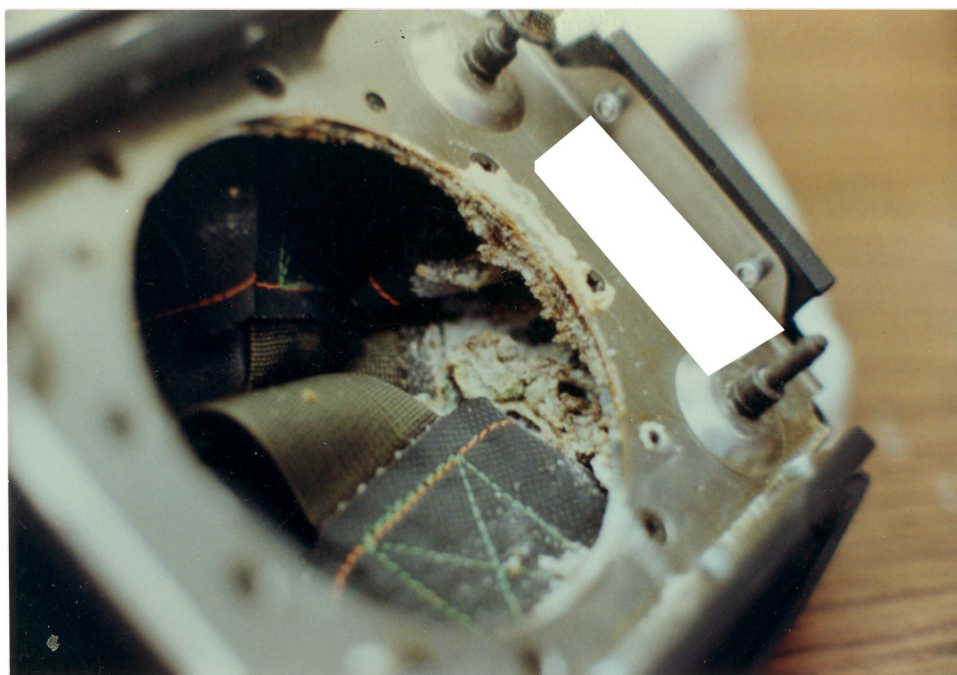
Generant Residue On The Inside Surface Of The Air Bag.

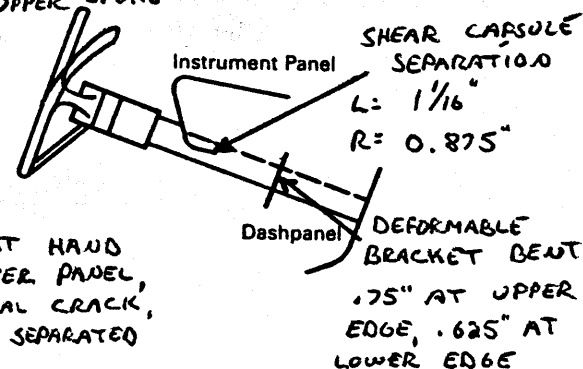
ABDOMINAL CONTACT TO STEERING WHEEL  
RIM, WHEEL PROBABLY ROTATED 180° AT  
TIME OF CONTACT  
UPPER STEERING WHEEL DISPLACED

3.25" FORWARD, BENDING BEGINS 2" ABOVE  
LOWER (L) SPOKE, CONTINUES CW TO (R)  
UPPER SPOKE

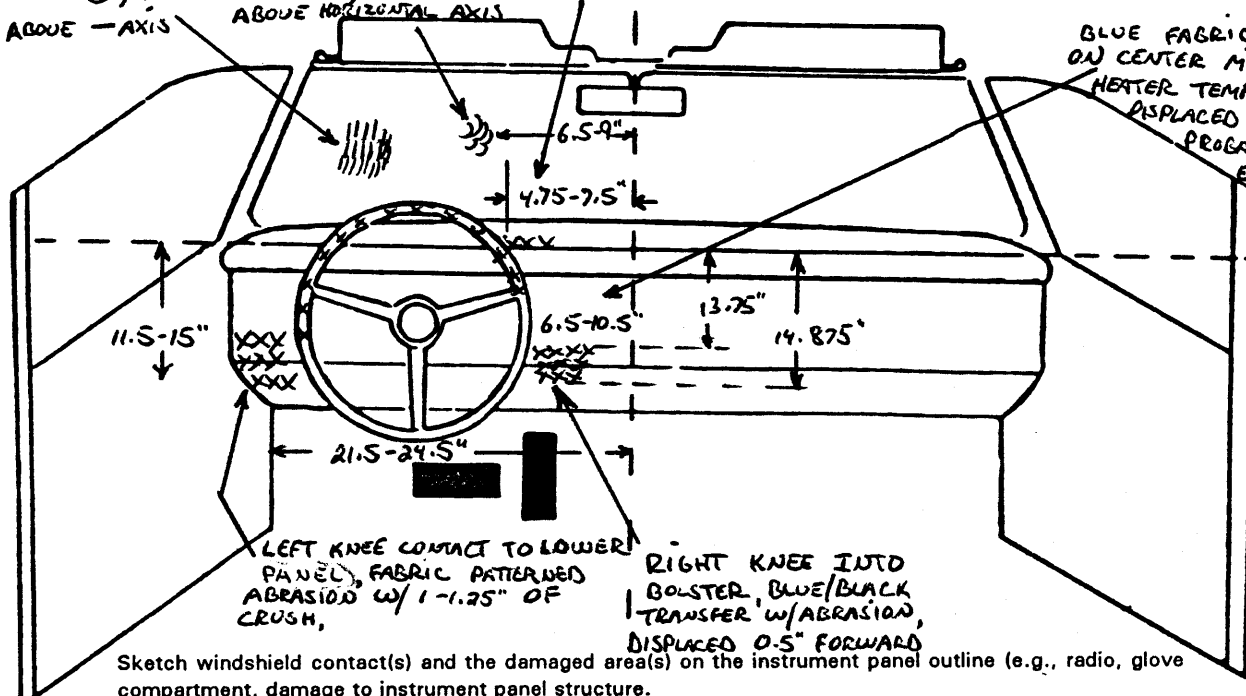
VERTICALLY ORIENTATED  
FABRIC (PROBABLE AIR  
BAG) TRANSFERS TO  
GLASS, 13-19" (L), 4.75-

9.25" ABOVE - AXISAPPARENT TISSUE  
TRANSFER TO GLASS  
OR SKIN ON CHUOGE  
6.5-9" (L) 6.5-8.25"  
ABOVE HORIZONTAL AXISPROBABLE RIGHT HAND  
CONTACT TO UPPER PANEL,

1.625" LONGITUDINAL CRACK,  
PADDING SLIGHTLY SEPARATED  
FROM PLASTICBLUE FABRIC TRANSFER  
ON CENTER MID PANEL  
HEATER TEMP. CONTRL  
DISPLACED TO RIGHT,  
PROBABLE (R)  
ELBOW CONTACT
